Barnitz Mill Rehabilitation and
Restoration Assessment

BARNITZ MILL REHABILITATION AND RESTORATION

MARCH 10, 2021

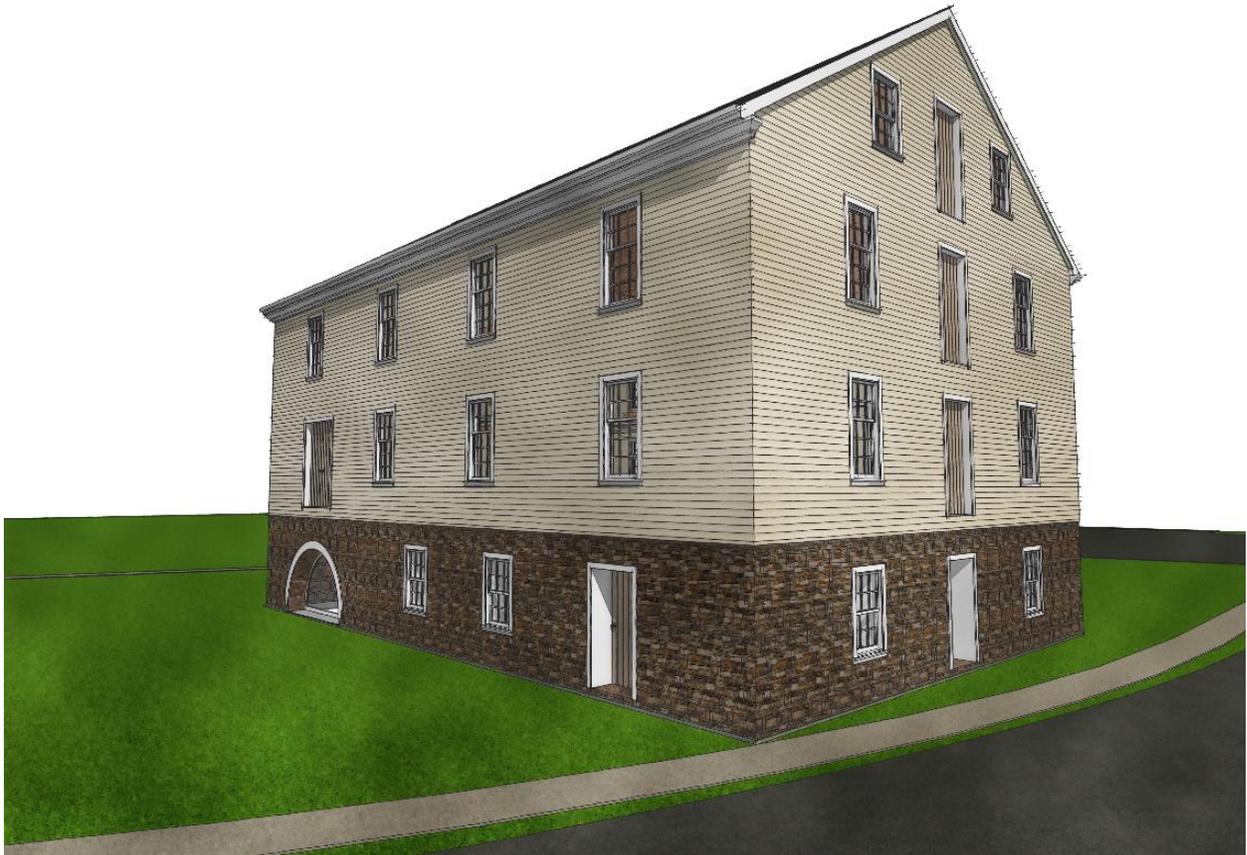
OPTION 1 - FULL RENOVATION AND POSSIBLE ADAPTIVE REUSE

This option is a complete renovation and restoration of the entire existing structure to serve as a living museum or adaptive reuse as a limited non-residential use. There are different code implications depending on the use which may require the installation of sprinkler systems or an elevator.

- Foundation stabilization outlined in structural report
- Frame stabilization outlined in structural report and possible reinforcement depending on reuse
- Floodproofing
- Exterior Shell Including siding repair, window repair or replacement, roofing and insulation
- Egress Stairs
- HVAC, Electrical, and Plumbing
- Accessible entrance and potentially elevators (depending on use)
- ADA Restrooms (depending on use)
- Sprinkler System (depending on use)
- Existing septic analysis and or upgrade
- Sitework and Parking

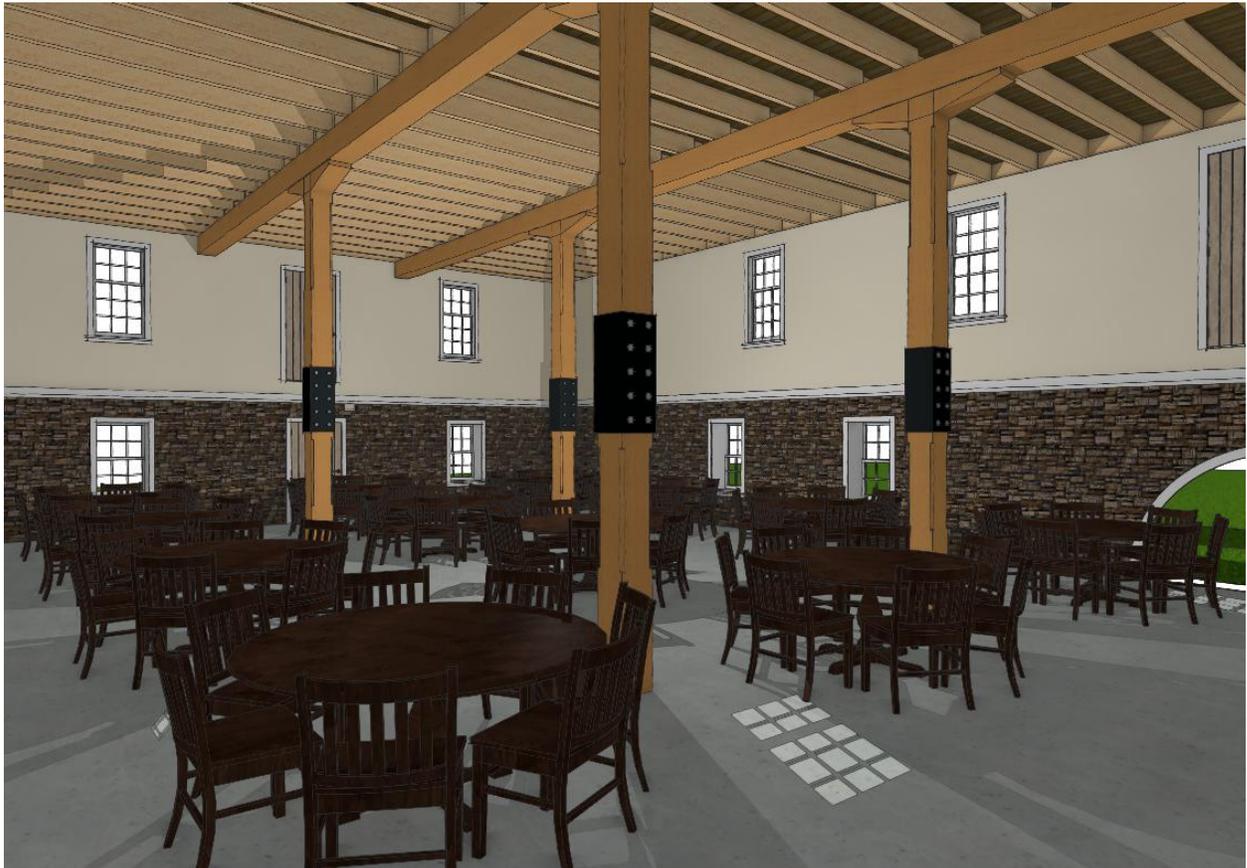
OPTION 2 - PARTIAL RENOVATION FIRST FLOOR EVENT SPACE

This option is a complete renovation and restoration of the building shell to preserve the historical character from the exterior but reimagines the interior as a vaulted event space. Installation of a new interior slab for the first floor and the removal of the second floor platform to create a vaulted interior space with two rows of windows. The third floor could be preserved as storage and support space but by only occupying the first floor we avoid the need for emergency exit stairs and elevators and the expense of repairing the second floor framing which has largely collapsed at one end. This kind of space could be outfitted for weddings, concerts or meetings.

- Foundation stabilization outlined in structural report
- Frame stabilization outlined in structural report and modification for vaulted first floor
- Floodproofing
- Exterior Shell Including siding repair, window repair or replacement, roofing and insulation
- HVAC, Electrical, and Plumbing
- Accessible entrance
- ADA Restrooms
- Sprinkler System (depending on use)
- Existing septic analysis and or upgrade
- Sitework and Parking

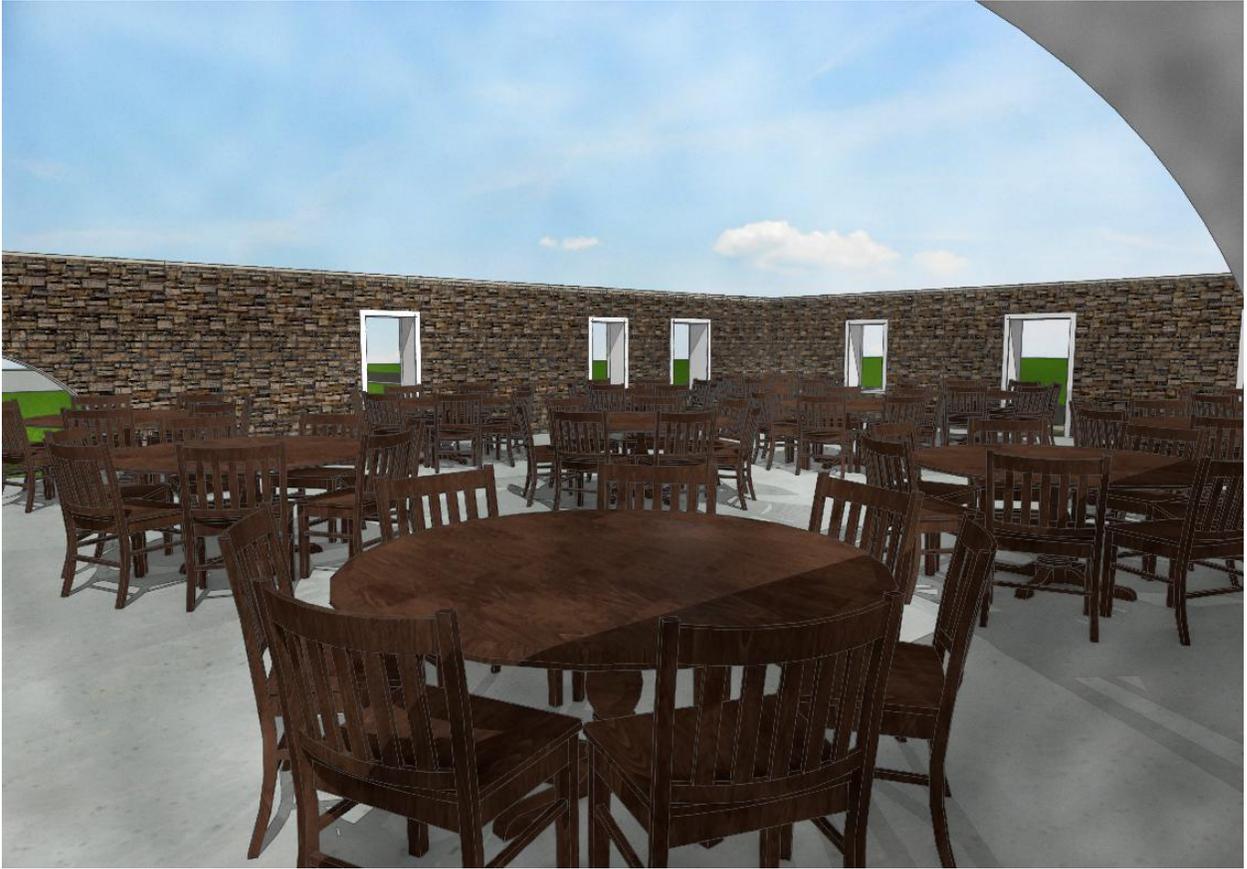
OPTION 3 - DECONSTRUCTION AND OPEN AIR EVENT SPACE

This option is aimed at preserving what's left of the original structure by dismantling the frame down to the foundation. Preserving the foundation allows the opportunity for education about the history of the mill and preserves its presence in the park without the cost of restoration. The timbers could be stored for reuse or relocation or sold to offset some of the costs. The idea is to repair and preserve the stone foundation walls with its arches and window openings and create a new concrete slab interior to create a space for outdoor wedding or concerts. This option could include some lighting and electrical connections to support these uses and could be paired with a removable tent to increase versatility. As an open air pavilion, this concept could make use of restroom facilities already planned for the park and would avoid the need for additional facilities.

- Foundation stabilization outlined in structural report
- Removal of structural timber frame for reuse
- Electrical
- Accessible access
- Limited Sitework
